PRELIMINARY ASSESSMENT REPORT

Doyle, Frank J.

EPA ID NO. TXD980865109

LEONARD, FANNIN COUNTY, TEXAS

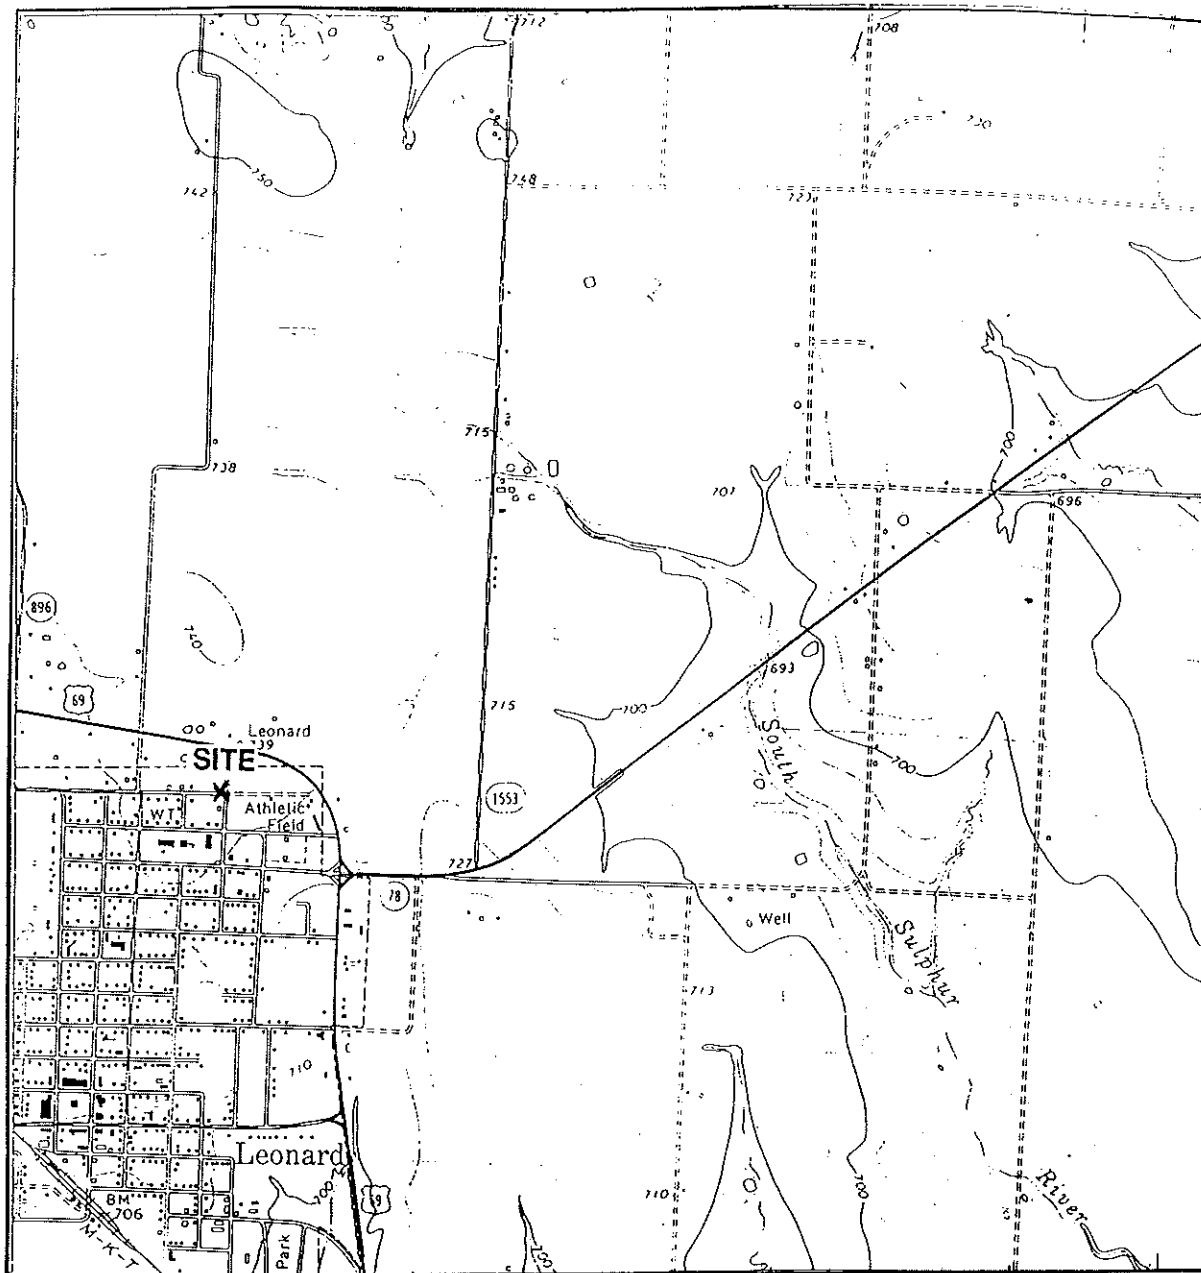
FIGURE 1
SITE LOCATION MAP
 Doyle, Frank J.
 EPA ID No. TXD980865109
 Leonard, Collin County, Texas

Note: USGS 7.5' Topographic Map, Leonard, TX Quadrangle, 1964.

The Doyle, Frank J. site, hereafter referred to as the Frank J. Doyle Transformer site is located at 305 E. Cottonwood in a predominately residential area of Leonard, Fannin County, Texas (Figure 1- Site Location Map). The geographical coordinates are 33° 23' 23" North latitude and 96° 14' 34" West longitude (Figure 1). To reach the site from Dallas, travel north on Hwy 78, turn west on Hackberry Street, then north on Poplar Street. The site is located on the corner of Poplar and Cottonwood. The site is bound on the north, south, and west by residential homes and the Leonard High School to the east (Figure 2- Site Sketch).

is bordered by residential properties to the north, south and west, and Leonard High School to the east (Figure 2). The owner, Mr. Frank J. Doyle, retired in January 1997 and his son, Gary Doyle currently operates the business. The site reconnaissance revealed evidence of soil contamination with yellowish/green staining of the soil (Photos #7 & 8). In addition to the staining on the ground, the area around the shop showed signs of deterioration and staining (Photo #8). The site is located on relatively flat terrain that slopes gently toward the northeast boundary (Figure 1).
